BioMax Environmental
Environmental Consulting and Industrial Hygiene Services

February 8th, 2008

Mitigation Procedures for 10th Floor Mitigation – Break Room Area
Department of General Services Board of Equalization Building
450 N. Street
Sacramento, California

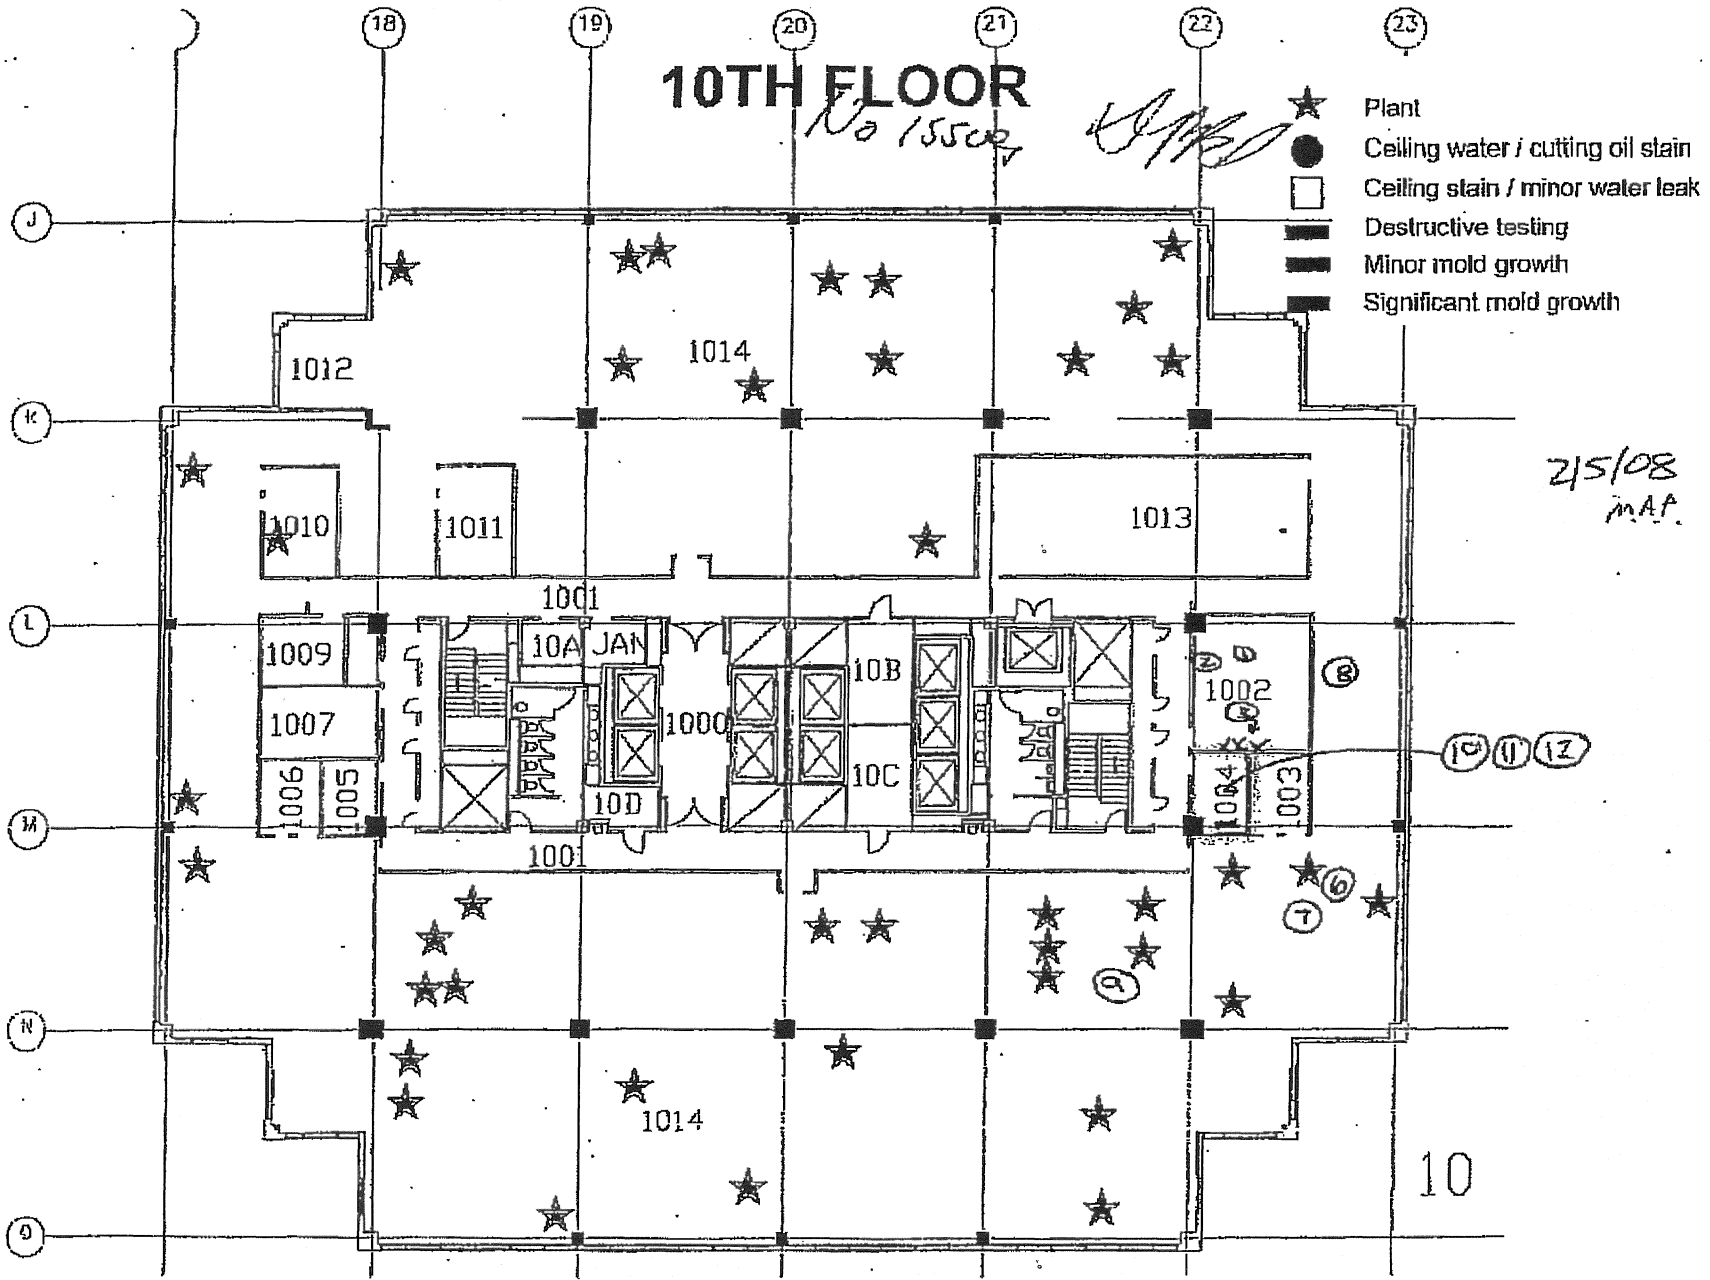
10TH Floor
Break Rm Areas

X - Baseboard covered
+ taped
